# Restoration and Reconstruction of Sendai Wastewater Utility after the Great East Japan Earthquake

Construction Bureau  
City of Sendai  
JAPAN

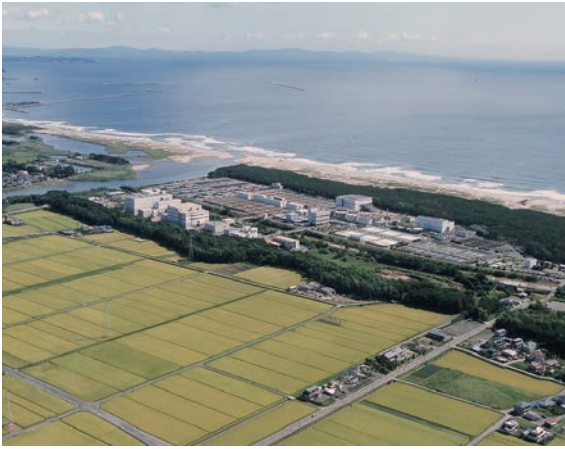
Panoramic view (before the disaster)

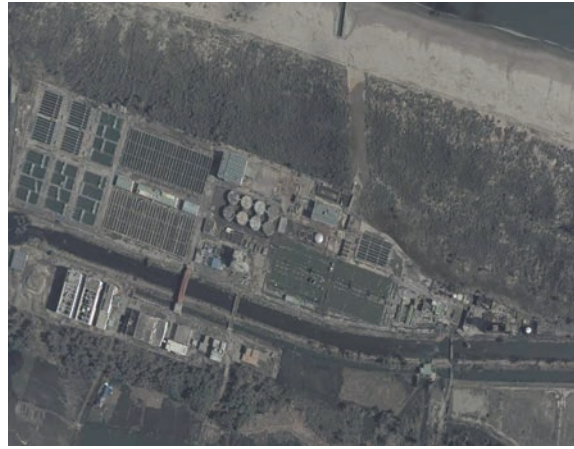
Panoramic view (after the disaster)

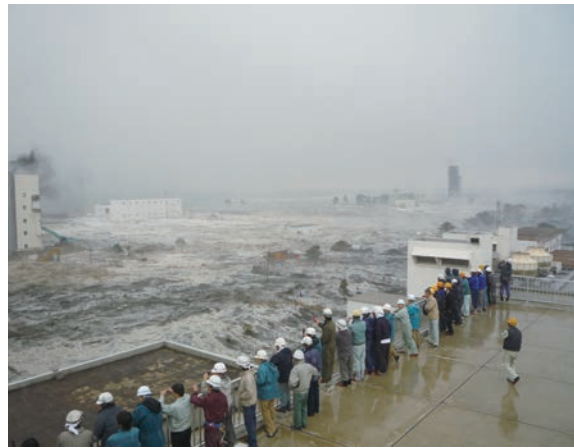
The moment hit by the tsunami

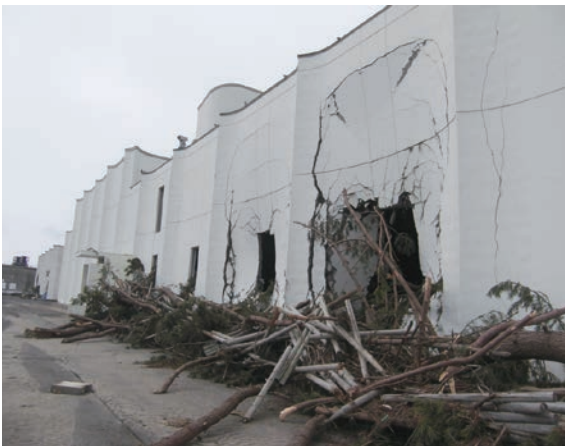
Wall surface of the blower room

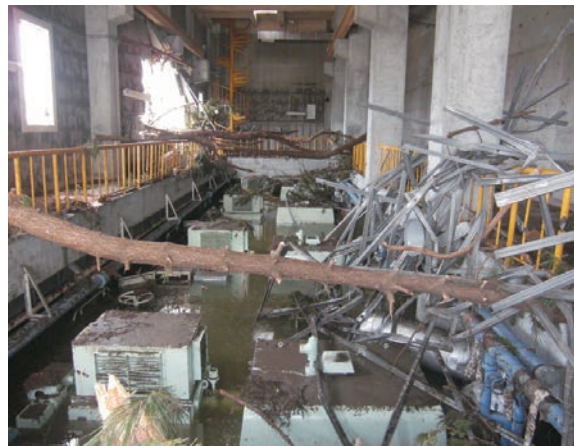
Inside of the blower room

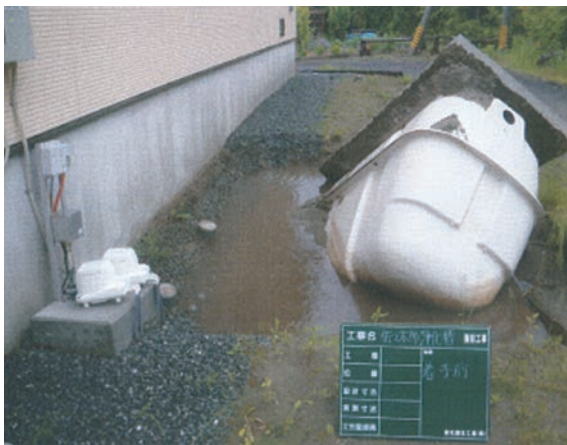
Fukuoka, Izumi

Septic Tanks (surfaced or upset by liquefaction)

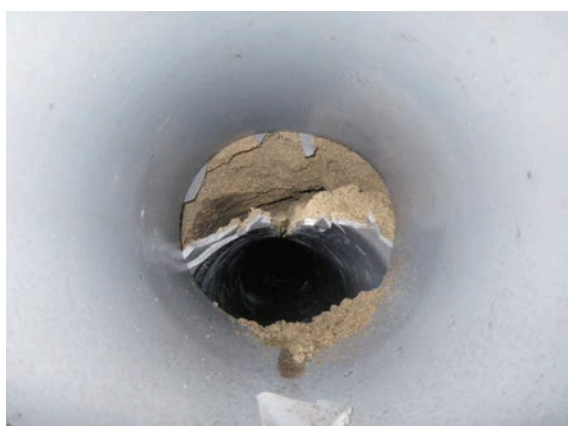
Thanks to the support of 12 municipalities, including Tokyo, over a period of about a month, we were able to complete a survey of damaged pipeline infrastructure in seriously affected areas. Then, although we were able to continue sewer service, it took nine months of further investigation to get a full picture of the damages. In the end, out of about 4,500km of pipeline, about 100km were found to be damaged, and have been restored.

The chloroethene pipe broken by the earthquake

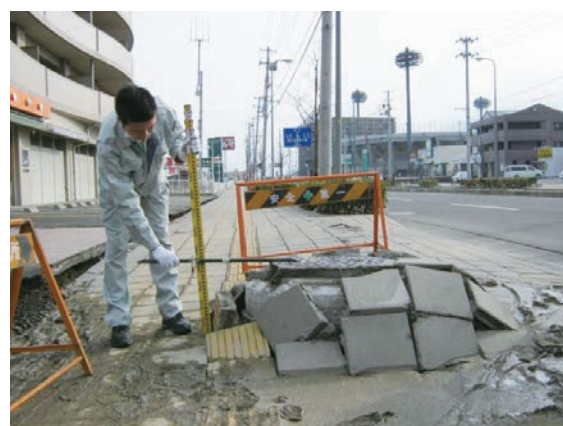
The Great East Japan Earthquake caused widespread pipeline breakage and accompanying road subsidence, manhole uplift due to liquefaction, and in hilly residential areas, breakage of pipelines and collapse of waterways due to landslides. Furthermore, Minami-Gamo Wastewater Treatment Plant and other sewerage facilities in the coastal area were severely damaged by the tsunami. The pillars and walls of the main pumping building were destroyed, rendering it unusable, and equipment was inundated, broken and washed away.

The floating manhole by liquefaction

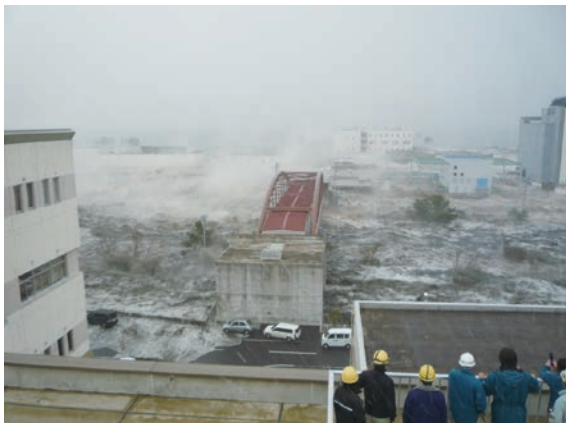
In particular, at Minami-Gamo Wastewater Treatment Plant, which treats approximately 70% of Sendai's wastewater, most equipment was rendered unusable by the tsunami, and civil engineering facilities were rendered unusable by rubble.

The moment hit by the tsunami

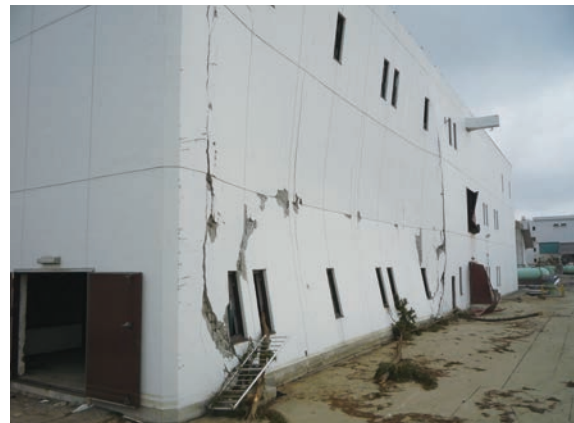
The 3<sup>rd</sup> pumping building with the wall curved by the tsunami

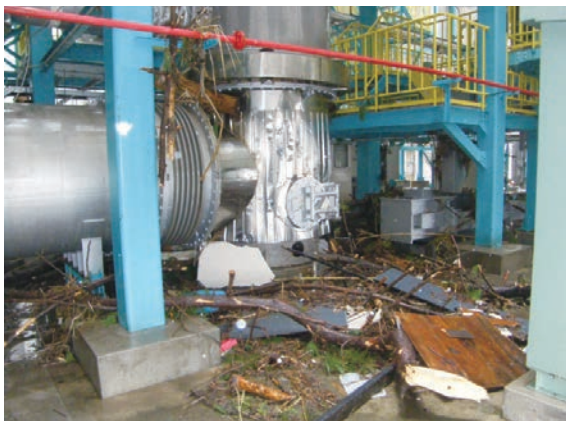
Damaged incinerator

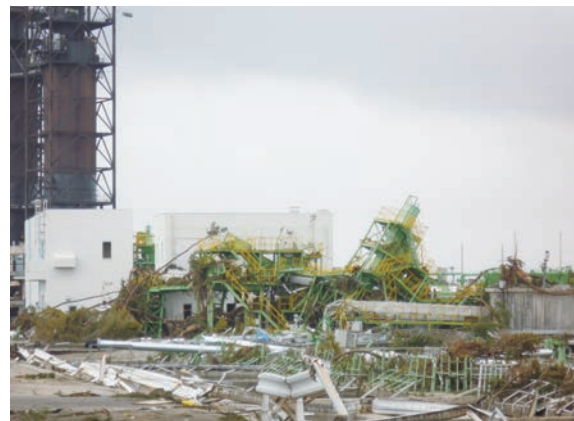
The damaged primary sedimentation tank

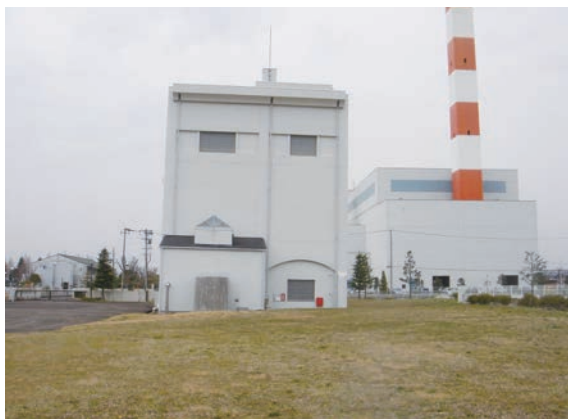
The Imaizumi Pumping Station tilted by the earthquake

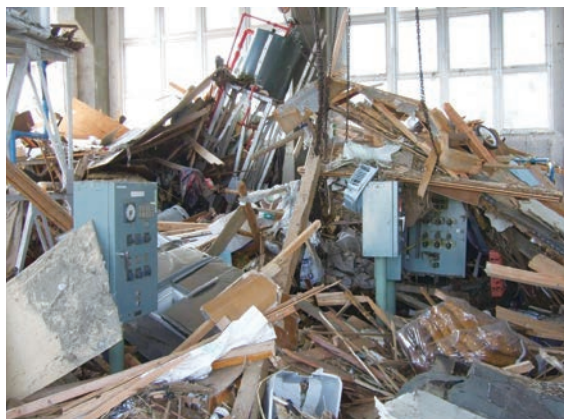
The Nishihara Pumping Rainwater Station covered by the debris after the tsunami

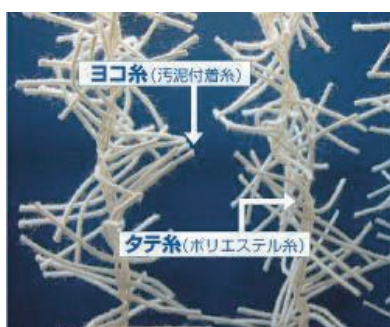
- Treatment process: Biological Contact Oxidation using a bio film method with string media (68 units/tank)
- Design flow: 300,000m<sup>3</sup>/day (average flow in good weather)
- Design influent BOD: 177mg/ℓ      Design effluent BOD: 60mg/ℓ
- Hydraulic retention time: 50 min.
- BOD volumetric loading: 5.2kg-BOD/m<sup>3</sup>/day
- Ventilation equipment: GM Blower (260Nm<sup>3</sup> x 400Kw x 2 units)
- Pre-aeration basin: Width 5m × Length 59.2m × Depth 4.25m × 4 channels × 2 pools (Volume: 102,000m<sup>3</sup>)

Sludge attached to string media

Accordingly, as a measure to improve the quality of effluent at Minami-Gamo Wastewater Treatment Plant by degrees, we decided to implement mid-level treatment through contact oxidation using string media. This is the first large-scale facility in Japan to adopt this method for use in sewage works.

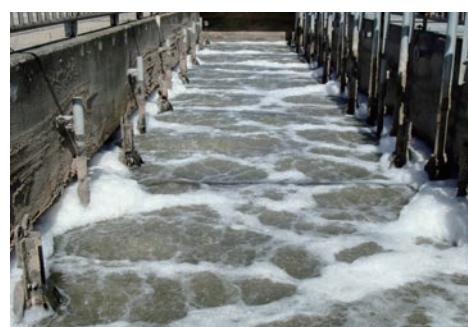
Biological Contact Oxidation

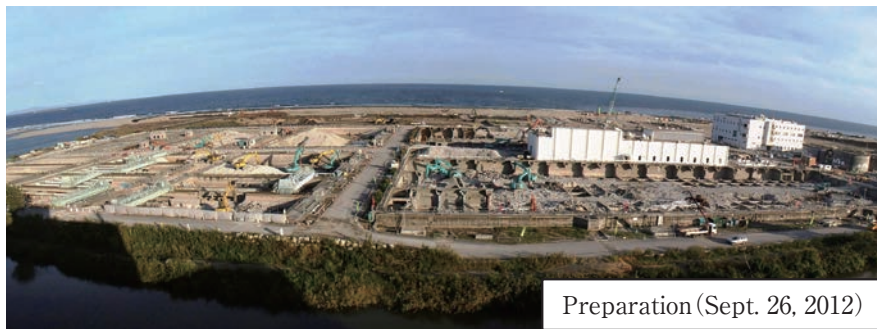
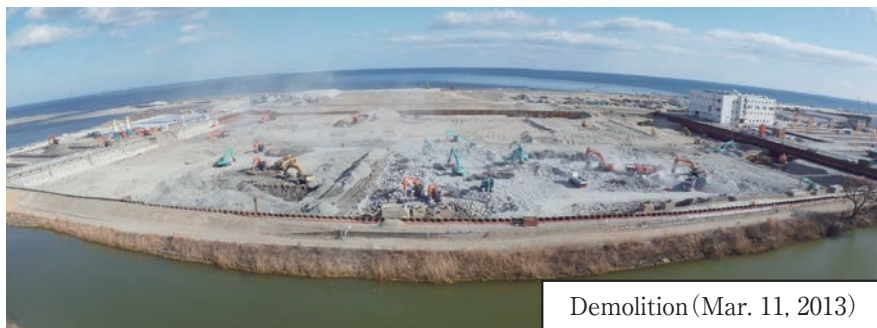
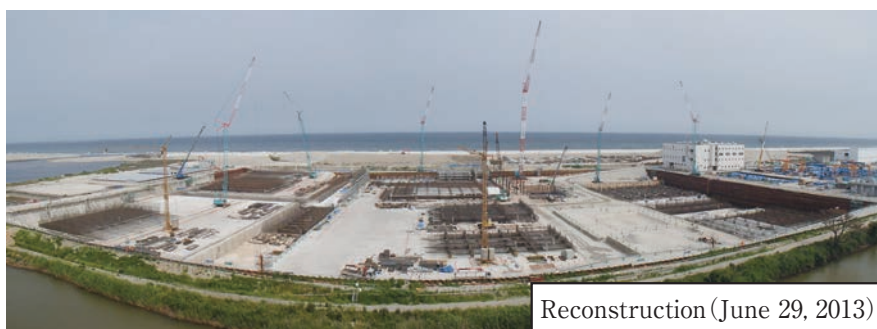
#### State of restoration of the water treatment facility (Preparation→Demolition→Reconstruction)

Percent completed: 30.6%

Restoration of the water treatment facility is scheduled to be completed by March 2016. Restoration of the sludge treatment facility is scheduled to be completed by March 2014. Regarding the current state of water treatment, please see “5. Temporary Water Treatment by Contact Oxidation”.
